## General Information

| Inspection Date | September, 01 2026 | Vehicle Type | Toyota SUV undefined 2026 |
| Location | REP | Registration no | SR-2D-5811 |

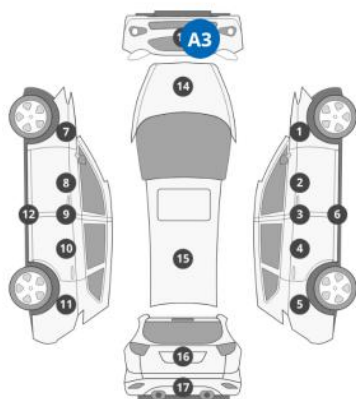
Illustration Damage

| Inspection Date | | September, 01 2026 | Vehicle Type | | Toyota SUV undefined 2026 |
|---|---|---|---|---|---|
| | Front Bumper | Scratch | | Medium | |
| 15 | Roof | Repair Traces | | Yes | |
| 16 | Trunk Hood, Rear Gate | Repair Traces | | Yes | |

recondition 250\$
